INCIDENT INVESTIGATION REPORT

Crude Oil Discharge to Lake Michigan

Whiting Business Unit

Incident Date: March 24, 2014
Investigation Start Date: March 26, 2014
MI/HiPo Notification Date: March 25, 2014
Report Issued: August 20, 2014
Traction Report: 4674318

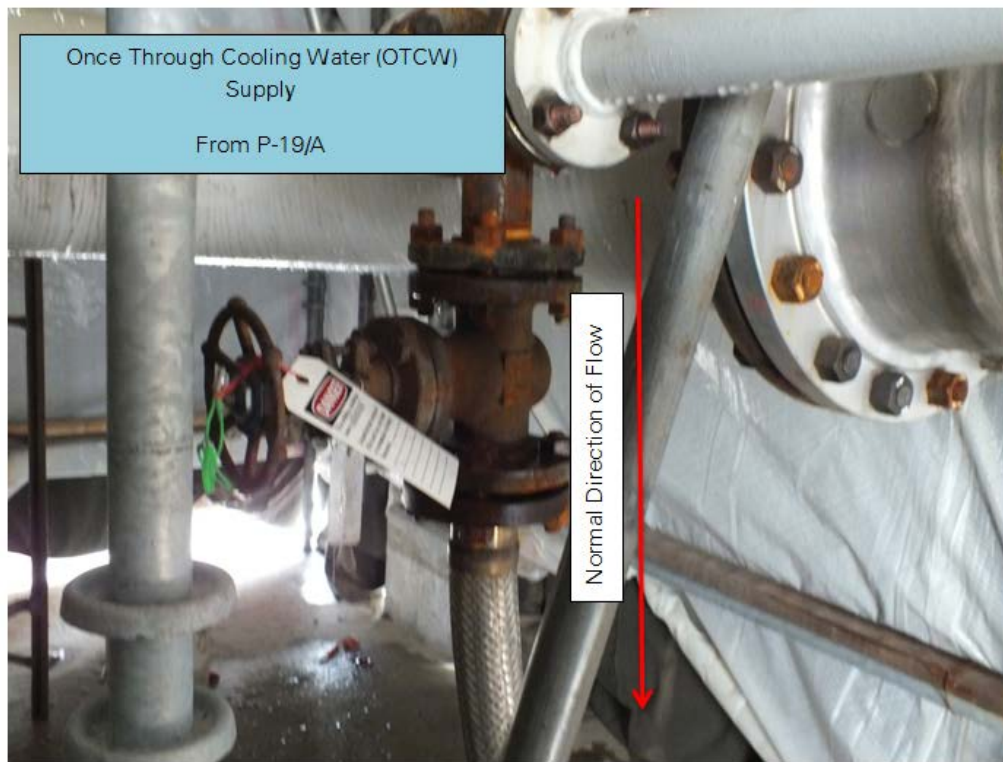
Figure 3 Connection of temporary quench line to the P-19A OTCW supply pump

The temporary quench line drew OTCW from a bypass near the P19A pump discharge (Figure 3). The quench line consisted of a 2-inch stainless steel braided hose connected to a 1-inch piping manifold with two 1-inch check valves that were connected to the brine system through two 1-inch bleed valves near the D-14 junction box (Figure 4).
